# Flood Mitigation at Tanjong Pagar

## Case Study

<b>Project:</b>	Flood Mitigation on Tanjong Pagar Road
<b>Year Completion:</b>	2021
<b>Design:</b>	Steel Pipe, Type 3 Drainage
<b>Designer &amp; Installer:</b>	Hocklim Engineering Pte Ltd

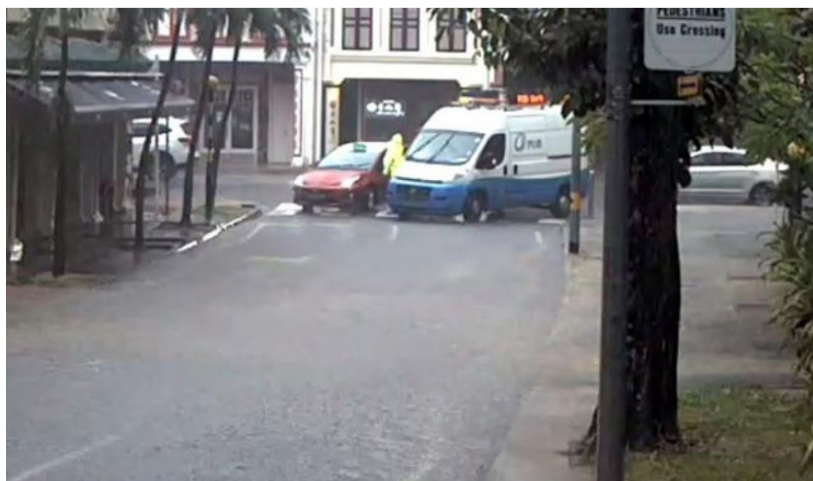
Figure 1: Flash Flood along Tanjong Pagar road - Craig road junction

Due to its geographical location, Singapore's climate is characterized by high humidity and abundant rainfall. During a heavy rainfall, flash floods often occur along Tanjong Pagar road especially at the junction of Craig Road and Tanjong Pagar Road where many F&B outlets are located. This often results in rainwater flooding into F&B outlets and affecting traffic along the road.

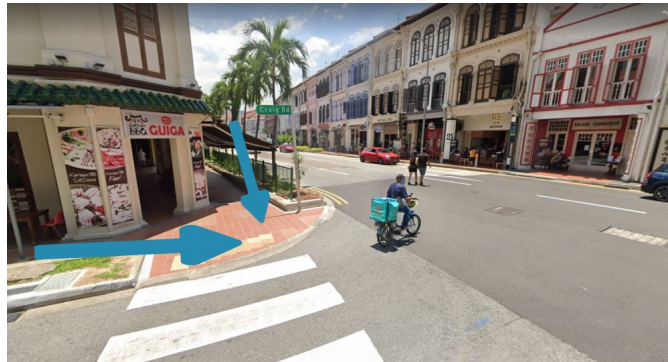
Figure 2: The blue arrows indicate the flow of water from the 2 drainages that intersects at the junction of Craig Road and Tanjong Pagar Road

During a heavy rainfall event, rainwater will flow downwards from Craig road towards Tanjong Pagar road, intersecting with another drain along Tanjong Pagar road. This will cause a clash in the water flow affecting the smooth flow of water towards the drainage across Tanjong Pagar road. This results in the build up of water, taxing the capacity of the drain as water accumulates at a faster rate than the rate of water draining off efficiently leading to flash flooding around the area.

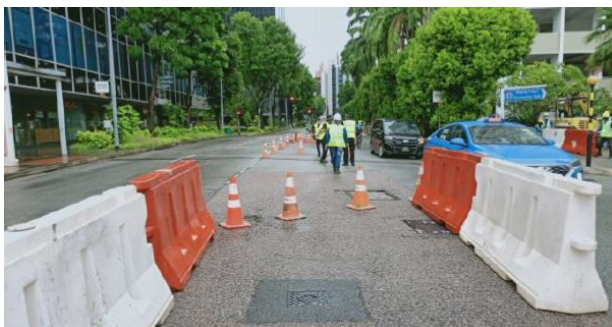
Figure 3: Setting up safety road measures before commencing work

Before the work commenced, we had to ensure that traffic was unaffected throughout the whole project. Our safety road measures were to close lane by lane when conducting trial trenches on each lane.

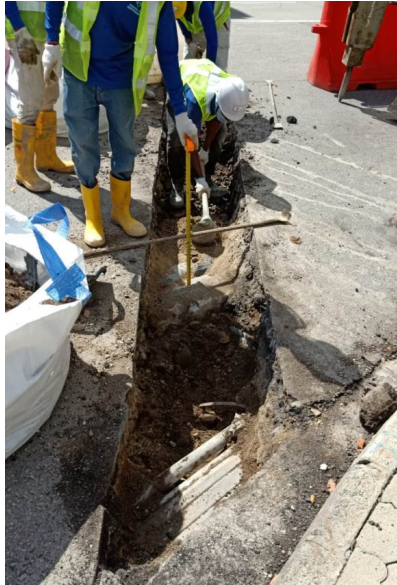
Figure 5: Manual Excavation to avoid damaging any existing cables or pipes.

Manual excavation was then carried out up to 1 meter deep to ensure that no cables were damaged. Once any cables were discovered, Hocklim will backfill and compact the excavated materials and reinstate with premix of existing thickness before moving on to another spot, repeating the same procedure until an area cleared of cables is found.

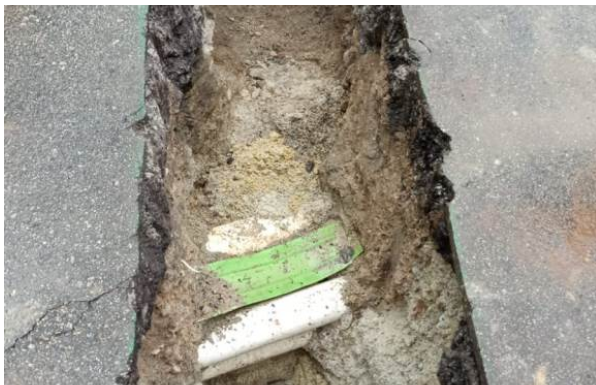
Figure 6: Existing Pipes that were discovered when digging the trial trenches.

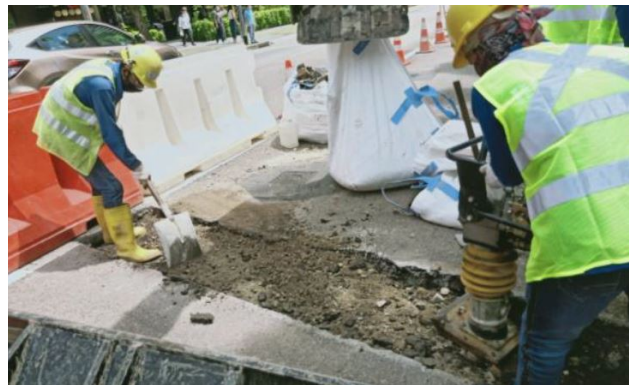
Figure 7: Backfilling the trial trenches

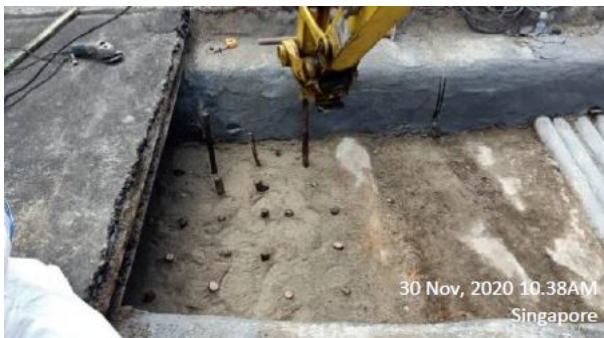
Figure 9: Bakau piling

Following the same format when excavating for the trail trench, Hocklim Engineering proceeded to excavate to a depth of 1.6m before installing Bakau piles to 3000mm deep with 300mm spacing apart to reinforce the foundation of the soil. After the Bakau piling, a 200mm thick hardcore base was laid before adding a 50mm thick G15 lean concrete creating a firm and level working base onto which heavy load-bearing surfaces can be laid. Following which, 2 layers of B10 mesh was laid before casting a slab of 100mm thick G35 concrete.

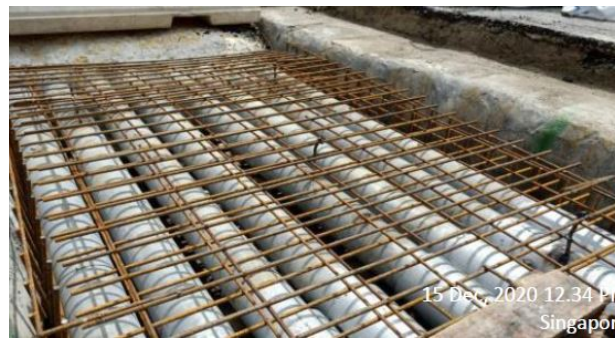
Figure 10: Laying 2 layers of B10 mesh on the steel pipes

After curing of the concrete base, 6 pieces of 8m x 114.3mm x 8.56mm thick steel pipe was laid in the area near Tras link while 8 pieces of 8m x 141.3mm x 9.52mm thick steel pipe was laid near Craig Road before repeating the process of laying 2 layers of B10 mesh and casting a slab of 100mm thick G35 concrete on top.

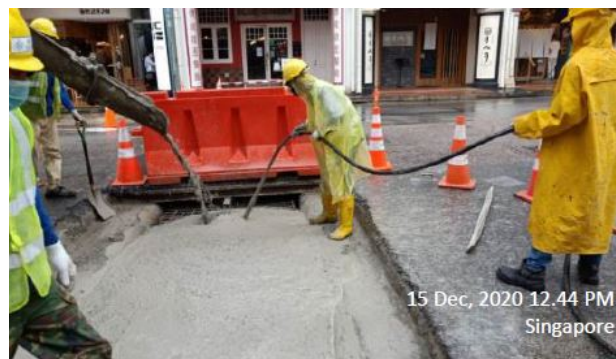
Figure 11: Pouring the cement onto the B10 mesh and pipes

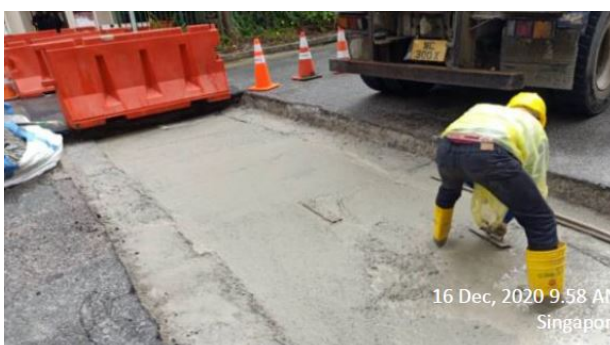
Figure 12: Floating the concrete before applying the Tack coat

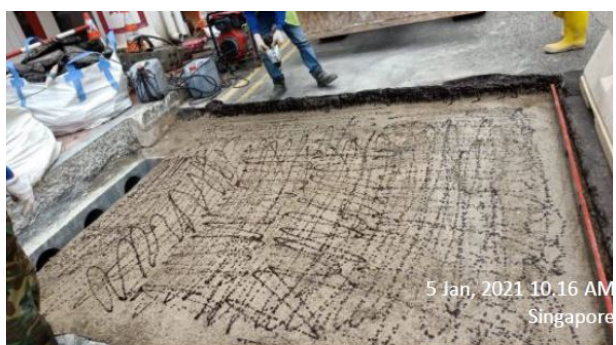
Figure 13: Applying Tack coat on the cement

After the concrete has cured, tack coat was applied before covering with the premix. This is to ensure the asphalt layer and concrete layer binds together to prevent any sliding or slippage failures that may occur between the 2 layers, thereby improving the durability of the road. After the tack coat is applied, the premix is then reinstated.

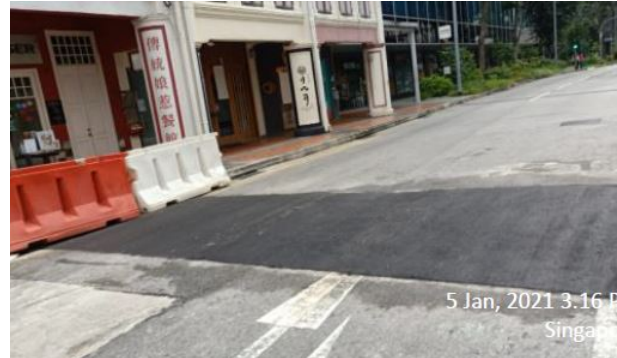
Figure 14: Premix reinstatement

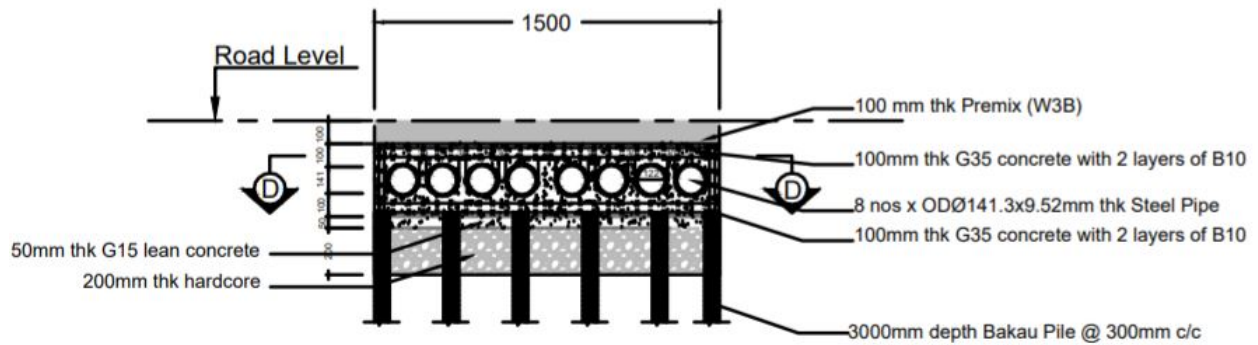
Figure 15: Cross section of the layers

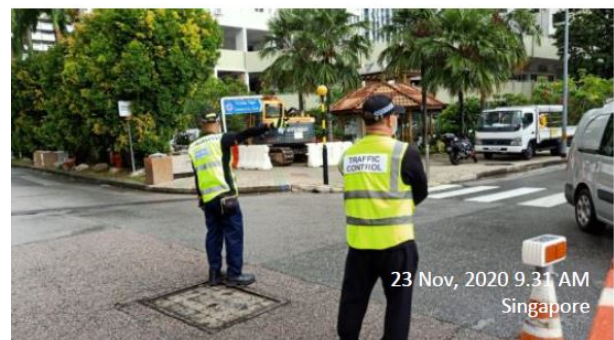
Since the proposed works are near a road junction, Auxiliary Police officers were engaged to assist with the traffic control as part of LTA road closure requirement.

Figure 16: Auxiliary Police officers controlling traffic

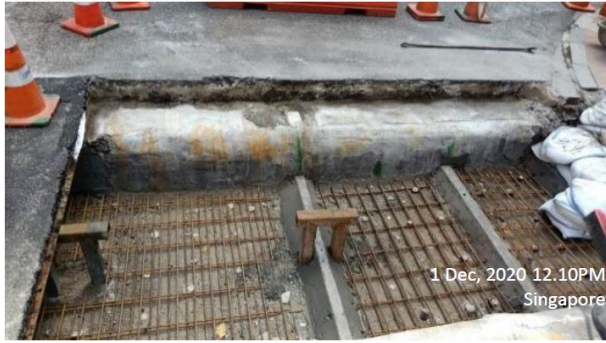
Figure 17: To provide more stability to the steel plates, the SHS sections were used as support for the steel plates

In the event that Hocklim was unable to backfill and reinstate a trail trench in time on that day or if LTA requires road to be open urgently, Hocklim will provide 25mm thick steel plates that has 50mm thick W3B premix to meet skid-resistance requirements by LTA. These plates were used to cover the trenches allowing work to continue while traffic is unhindered.

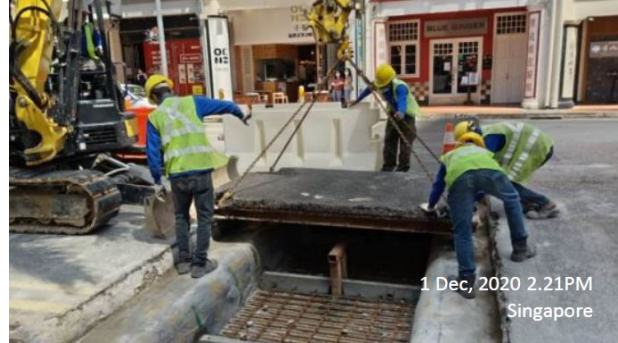
Figure 18: Laying the steel plates with 50mm thick premix and covering the trenches to allow traffic to operate.

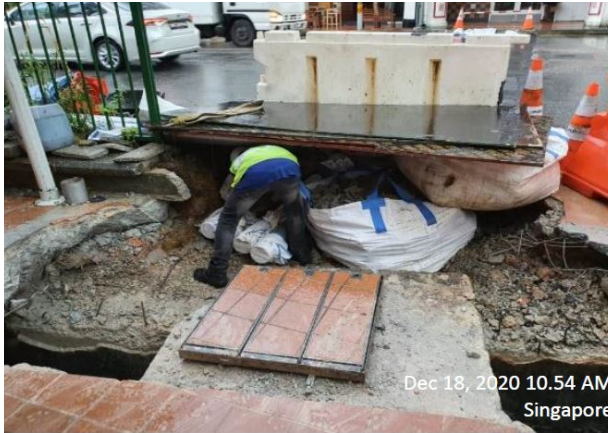
Figure 20: Connecting the Steel pipes to the drainage

After the hacking and excavation was completed, the steel pipes were then connected to the respective drainage. Once connected, the formwork was constructed. Cement was then casted to the drainage original height.

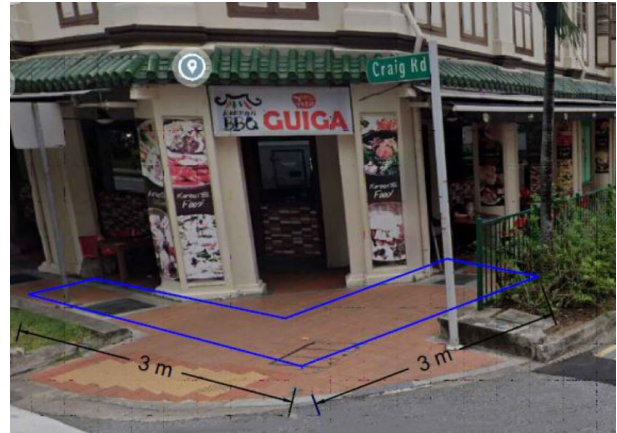
Figure 21: Pavement to be hacked (in purple) to connect the steel pipes to the existing drain

The next step was to connect the steel pipes to the existing drainage system. Hocklim had to hack the pavement in front of the shophouse to connect the existing drainage to the steel pipes. In addition, Hocklim will construct a type 3 drainage along Craig Road to further improve the rainwater flow into the drainage system.

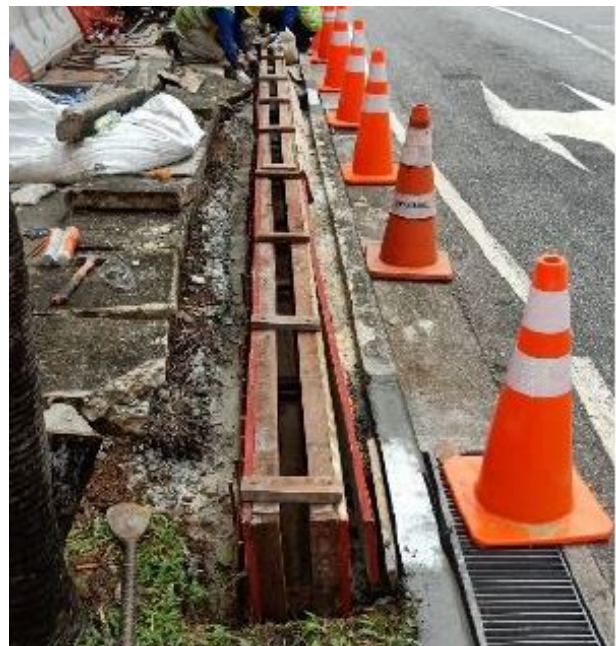
Figure 22: Formwork for type 3 drainage

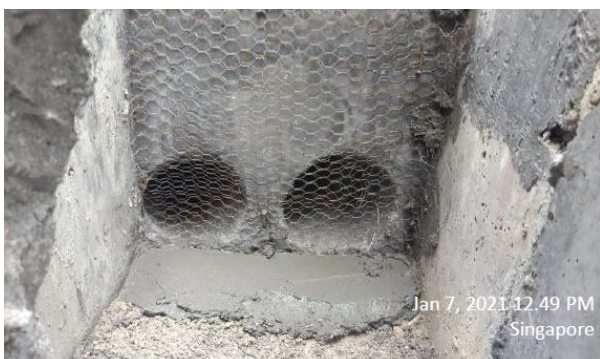
Figure 23: Casting of the concrete wall connecting the steel pipes to the drain

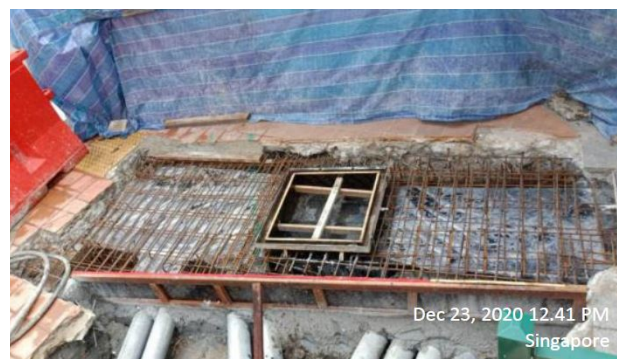
Figure 24: Laying of the Rebar slab

Following which the rebar slab was laid before casting a layer of Grade 35 concrete on top.

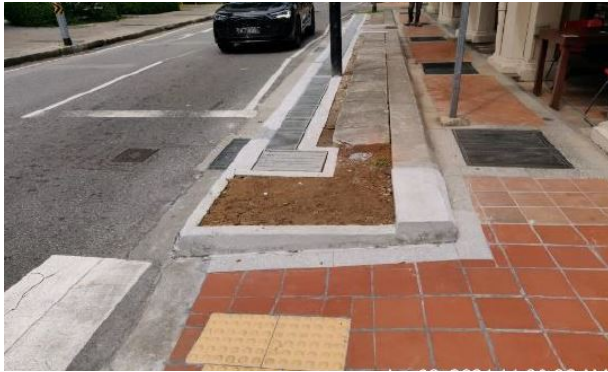
*Figure 25: Retiling of the pavement*

After the cement layer was laid, Hocklim proceeded to retille the pavement to its' original state and with the installing of the type 3 gratings along craig road, the amount of rainwater can flow through the DIC grating into the drainage system more efficiently, due to the increase in drainage capacity of the type 3 drain, thereby alleviating any flash flood along the Craig road- Tanjong Pagar road junction.

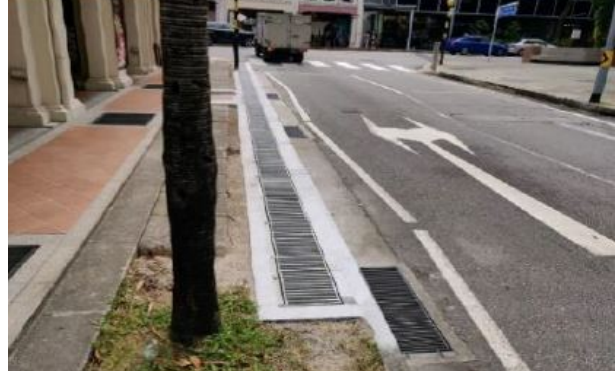
*Figure 26: Type 3 drainage completed*

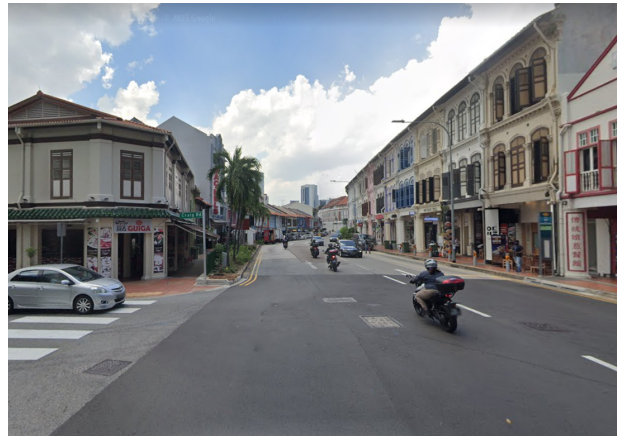
*Figure 27: Steel pipes installed along Craig rd - Tanjong Pagar rd junction*

In this project, the intersecting drains at the Craig road and Tanjong Pagar road junction causes the the build up of rainwater level in the area due to the inefficient water flow towards the drainage system across Tanjong Pagar road. The installation of the steel pipes connecting to the drainage on Tanjong Pagar road and Craig road respectively rectifies the existing bottleneck issue. This ensures that the rainwater is being drain off more efficiently and effectively to the drainage across Tanjong Pagar road, mitigating the flash flood around the area.
